# DOMETIC HEATING FURNACES

## EN Furnace Limit Switch Service Bulletin

Model	Serial Number Range
All Small & Medium Furnaces (AFS, AFM, DFS, DFM)	73985322 – 81099541

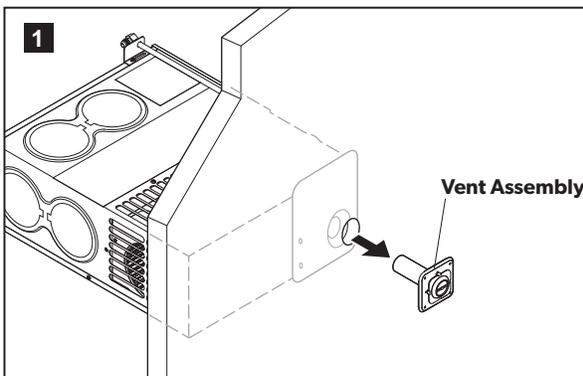
### 1.1 Removing the vent assembly

The cause of this nuisance issue is a mistaken omission of a plastic wire tie to suspend the heat exchanger limit switch wires up and away from the exhaust tube vent terminal. The omission of this component allows the limit switch wires to potentially melt on the vent terminal, shorting to ground, and causing either the fuse or circuit breaker in the circuit to blow, or the sail switch to become inoperative. **In ALL cases the safety devices in the system are performing as designed and prevent the furnace from operating.**
